M E M O R A N D U M

July 18, 1994

ALBION-SHERIDAN TOWNSHIP LANDFILL TEST PITTING

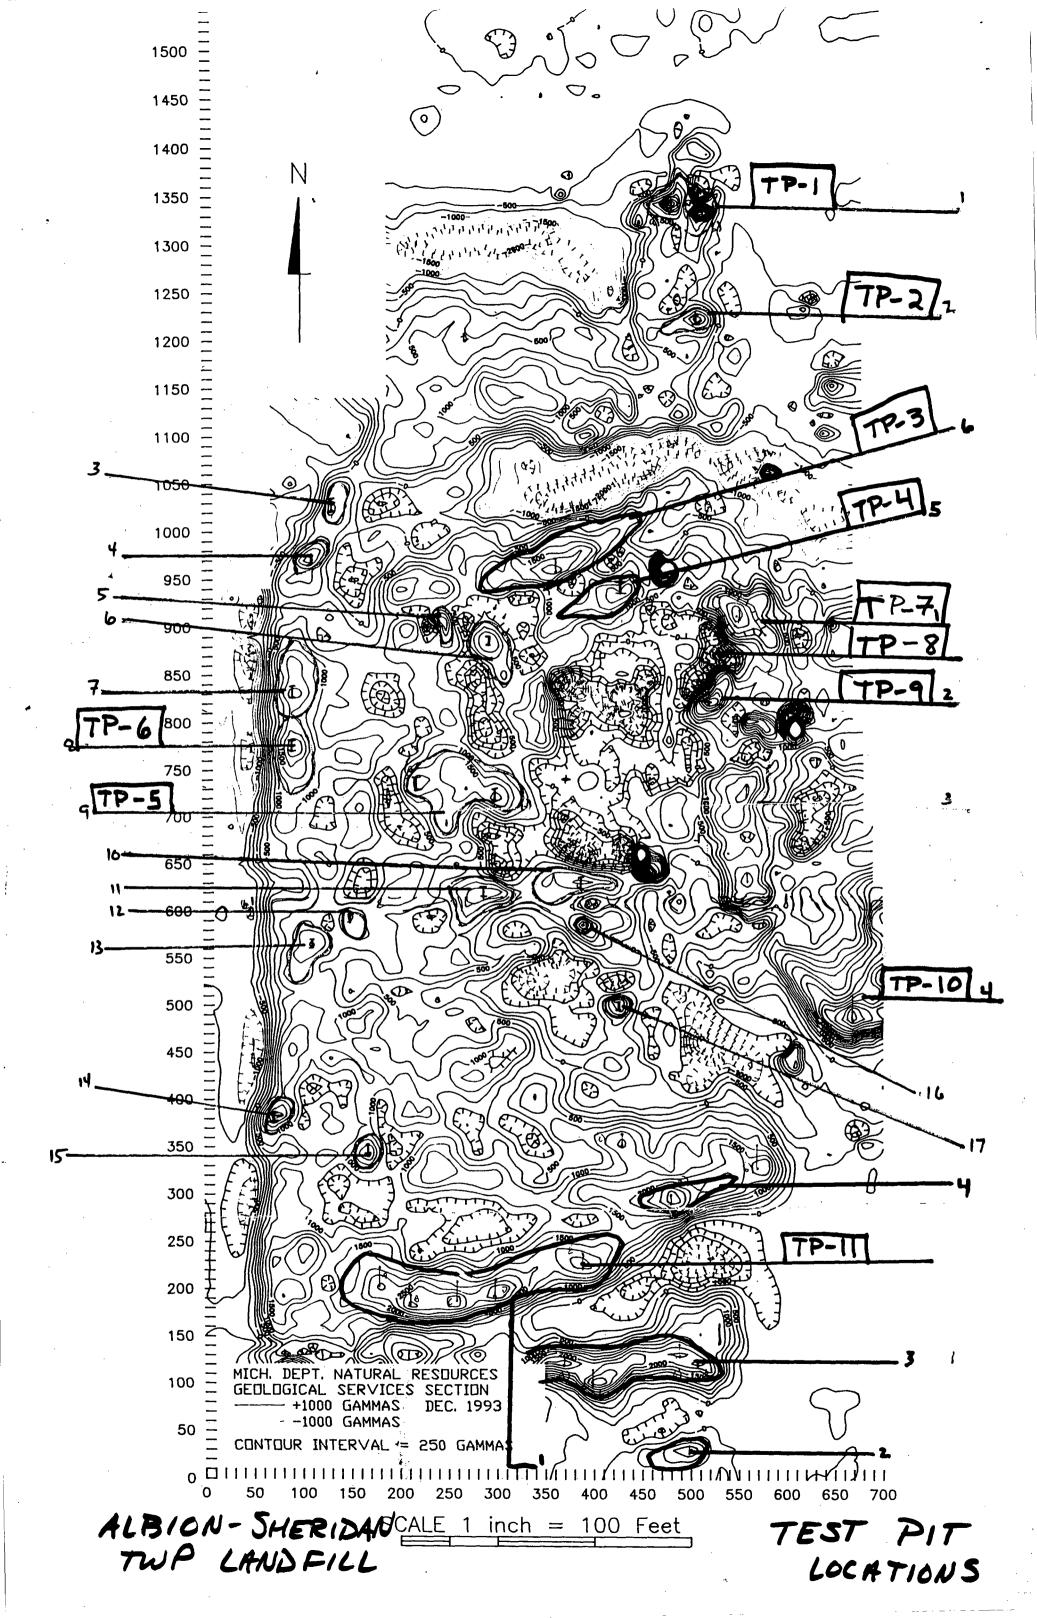
samples from two drums that had been overpacked the previous day (TP-9-8 and TP-9-9). The dimensions of Test Pit #9 were irregular. See attached sketch.

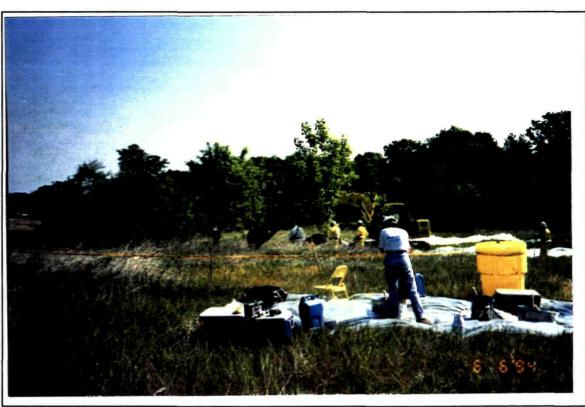
10:10 - 10:48 am: Performed test pitting at Test Pit #1. One crushed drum carcass was found. Other material included wood, metal debris, tin, and foundry sand. The MDNR videotaped excavation activities. The total depth of the excavation was 7 feet. The excavation was backfilled. The original surface material was not segregated and place back on top of the excavation as indicated in the work plan. No abnormal air monitoring readings were reported to Earth Tech staff.

Comments: Test Pit #1: Exclusion zone and support zone.

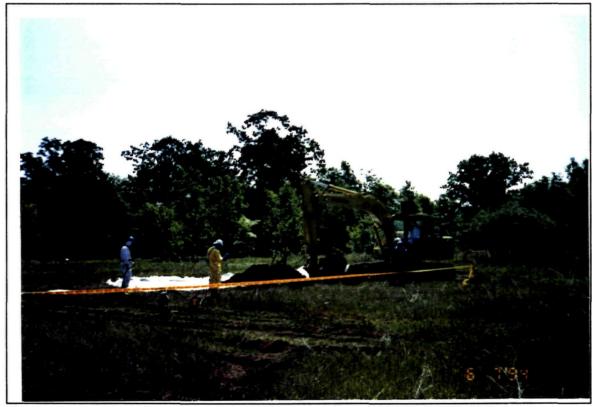
11:05 - 11:30 am: Performed test pitting at Test Pit #2 which is just south of Test Pit #1. One crushed drum carcass was found. The material present in this test pit was similar to what was found in Test Pit #1. The MDNR geophysicist wanted to excavate in another area close to Test Pits #1 and 2 and the MDNR project manager made the decision not to.

Comments: Test Pit #2: Video cam and fire extinguisher evident.

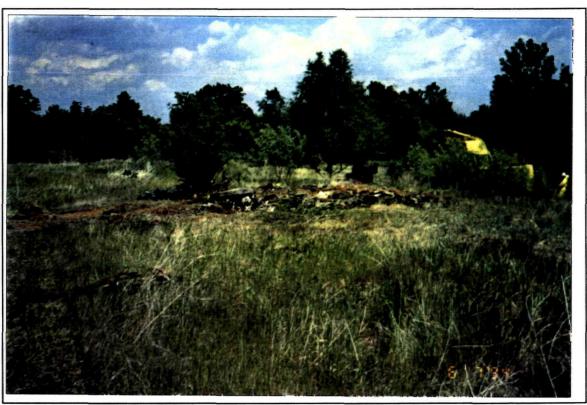
1:25 - 1:50 pm: Performed test pitting at Test Pit #3. No drums were present in this test pit. The excavated materials appeared to be typical municipal landfill debris.

All of the test pits had been filled back in, however, trash was evident at the surface. This was an earlier concern of Earth Tech's and the U.S. EPA. We had asked whether they were going to place clean fill at the surface. The investigators had indicated that they will segregate the cover material during excavation and place this back on the surface. This did not occur.

Comments: Test Pit #3: Excavation complete, restoration resulted in trash left at surface.

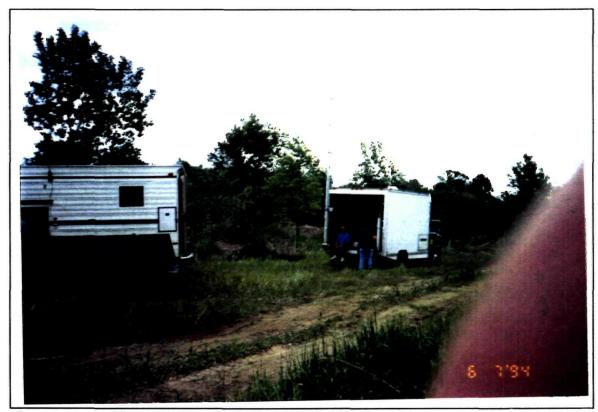
Air monitoring vehicle set up for Test Pits #3 and #4. Comments:

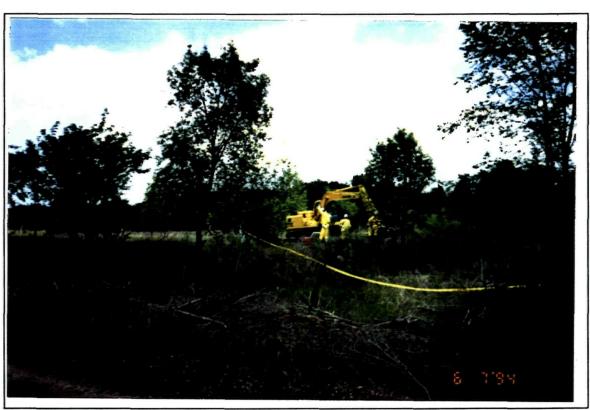
3:33 - 4:15 pm: Performed test pitting at Test Pits #5 and 6. Landfill cover appears to be sandy soils at both sites. Found glass, metals, plastic, rags and one crushed drum carcass in Test Pit #5. The dimensions of Test Pit #5 was approximately 14 feet long and 7 feet deep. Found similar material in Test Pit #6, however, no drums were encountered. The total depth of Test Pit #6 was approximately 7 feet.

Comments: Test Pit #5 location

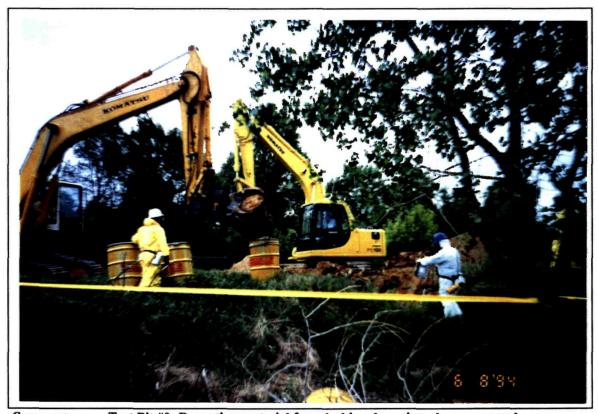
~9:30 am - 6:30 pm: Performed test pitting at Test Pit #9. The first drum nest encountered was of 5 drums located 3-4 feet below the ground surface. One of these 5 drums was leaking and this was overpacked. The liquid in this drum (Drum #1) had a cloudy appearance and registered 150 ppm on the HNu. According to one observer next to the excavation, the material looked like silver paint floating on water. A sample was collected of this material and labeled, TP-9-1.

Comments: Test Pit #9: Decanting material from leaking drum into drum overpack.

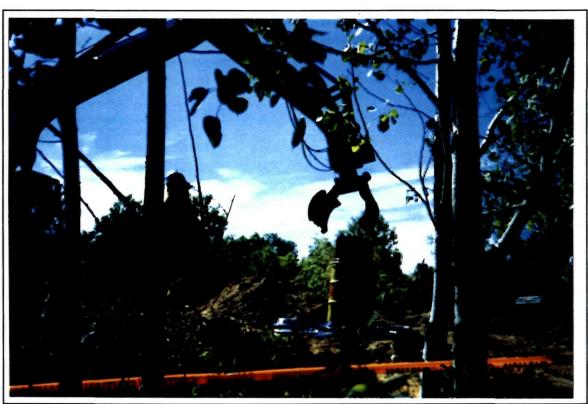
Comments: Test Pit #9: Encapsulating leaking drum into drum overpack.

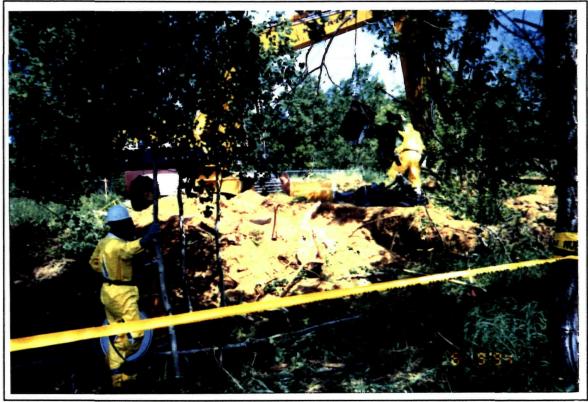
4:00 pm: The backhoe was moved to a southerly location within Test Pit #9. The excavators hit another drum (Drum #7) which contained what appeared to be the same material as the previous drum (white paint sludge?). As the drum was removed from the excavation, white sludge-like material poured out onto the ground. The drum was overpacked and the material was also shoveled into the drum overpack. No sample of this material was collected for analysis.

Test Pit #9: Removing leaking drum from excavation. Notice liquid pouring out of Comments: it. Note liquid running down the slope.

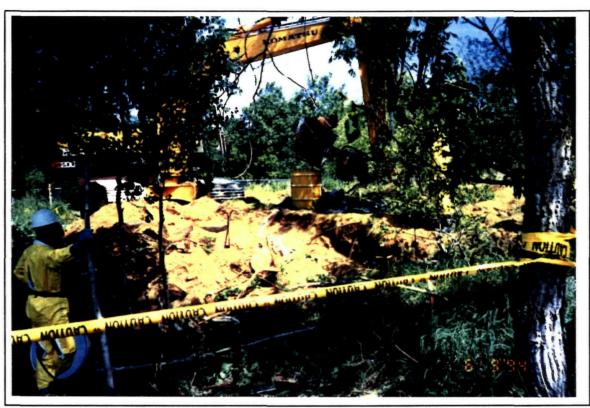
Comments: Test Pit #9: Decanting liquid into drum overpack. Liquid noticeable on slope.

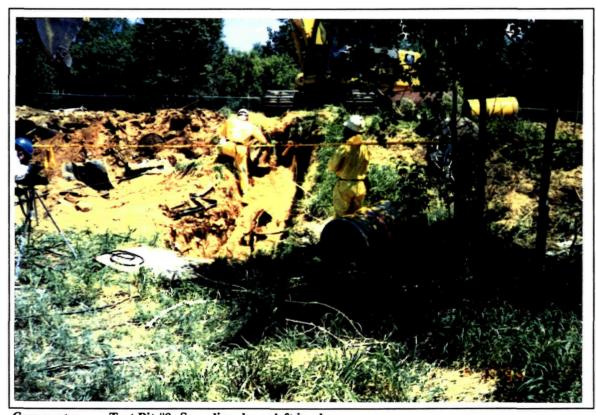
9:50 am: Investigators returned to Test Pit #9 to further define it's extent. A drum (Drum #8) was encountered in the SE corner at approximately 10:20 am. A sample was collected and labeled TP-9-5. There was only enough material to sample for VOCs. The material in the drum registered 450 ppm on the HNu. At this point, the MDNR SPM indicated to the Earth Tech representative that investigators felt that they had adequately defined the extent of the drums in the NE corner. They were going to collect a sample of the white sludge-like material from Drum #7 which they had overpacked yesterday. Investigators encountered another drum that they sampled and labeled the sample TP-9-6. The drum, however, was left in the ground.

Comments: Test Pit #9: Sampling drum left in place.

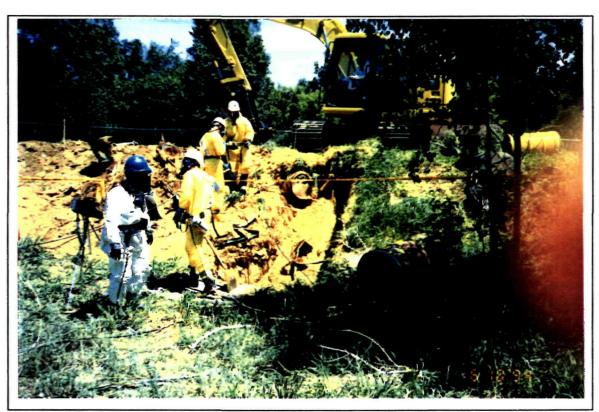
6:15 pm: Apparently, this drum had a large hole in it and most of the liquid in the drum drained out. A decision was made to leave this drum in the excavation.

Comments: Test Pit #9: Drum left in place.

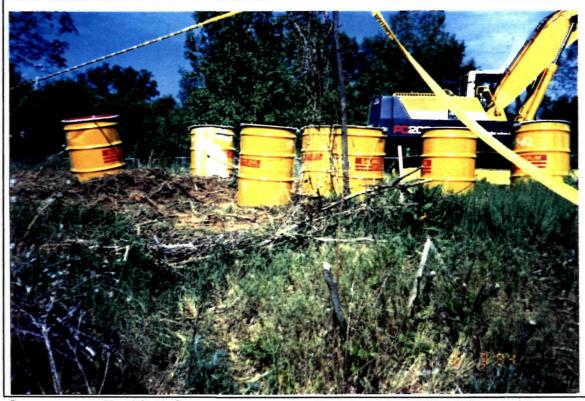
Comments: Test Pit #9: Seven drum overpacks. Note drum second from left, material spilled on outside.

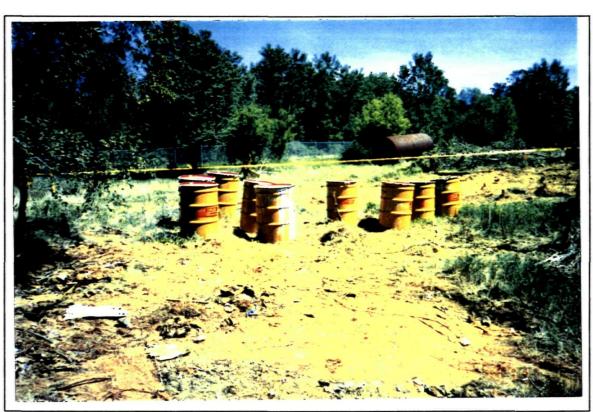
There are a total of nine overpacked drums which were left on the decon pad built by Earth Tech for the RI Investigation. A total of nine samples were collected in addition to one duplicate sample.

Test Pit #9: After excavation and backfilling test pit, nine drum overpacks result. Comments:

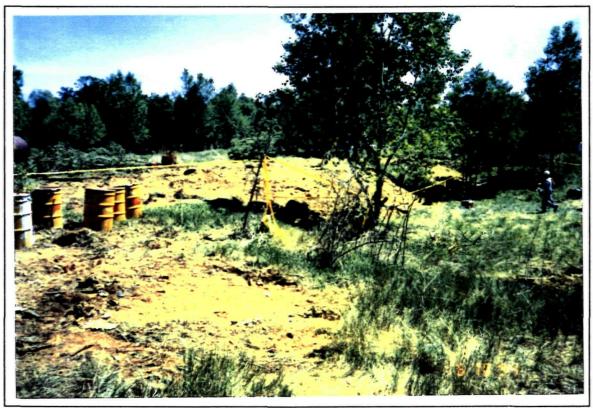
Comments: Test Pit #9: Post excavation and backfill.

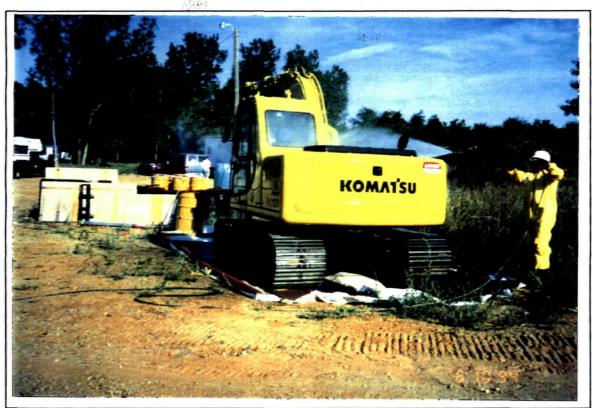
Deconning backhoe at the conclusion of the test pitting. Comments:

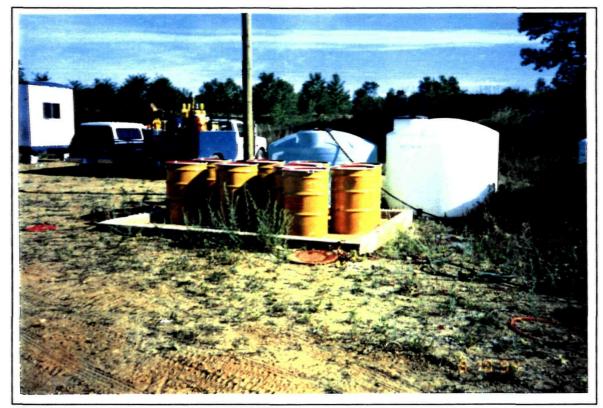
No test pits were performed. The overpacked drums were transferred to the decon pad. There was approximately 10 gallons of decon water left in the poly tank at the site. The MDNR SPM indicated to the Earth Tech representative that they were working on who's responsibility it was to dispose of the drums and the decon water.

Final resting place on nine drum overpacks. Comments:
